Effect of Excavation Dewatering on Adjacent Structures

Magdi M. E. Zumrawi, Elhaytham Hassan

Abstract: The study aims to investigate the effect of dewatering technique on retained ground and adjacent existing structures in order to avoid any damages that may occur. The paper presents three cases of potential structure failure caused by ground settlement as a result of dewatering. Two current construction projects in Khartoum North were selected as a case study. The two projects are located near Blue Nile River where ground water table exists at shallow depths. Dewatering to reduce the groundwater level was carried out in the two sites to facilitate excavation works. The buildings and road pavements around the two sites suffered serious damages due to excessive differential settlements of the retained ground. The study results showed that there are numerous sources of risks associated with performing dewatering. Therefore, developing appropriate plan for dewatering before construction is essential to mitigate any adverse impacts and avoid risks.

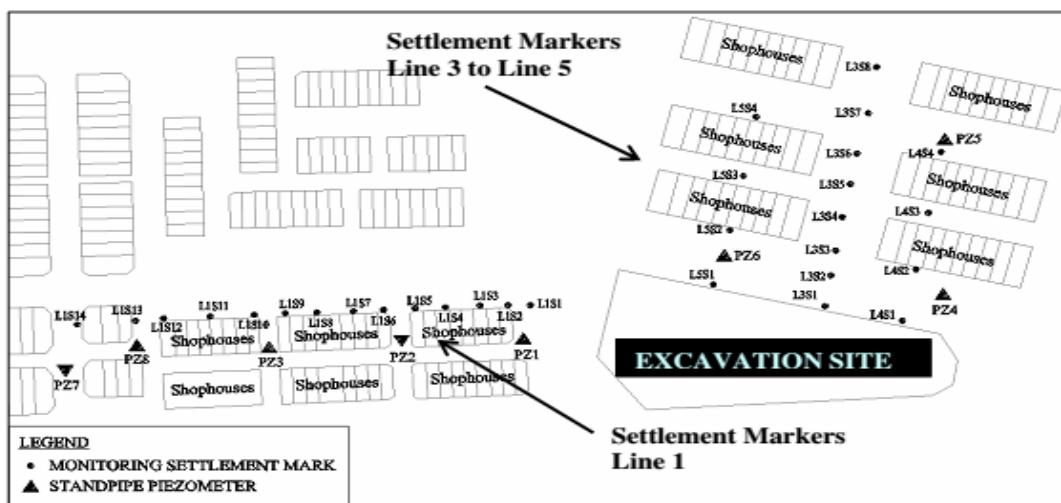
A case of structure collapse event due to dewatering occurred in Malaysia, [14]. The project is a basement excavation in Sarawak Malaysia. Many three-story shop houses surrounding the project site which have suffered cracks and significant settlement of the apron slabs and drains. These shop houses are supported by bakau piles (a type of natural wood piles). The excavation site surrounded by many shop houses with settlements markers lines are shown in **Fig. 3**.

Fig. 3. The project excavation site surrounded by many shop houses, [14]

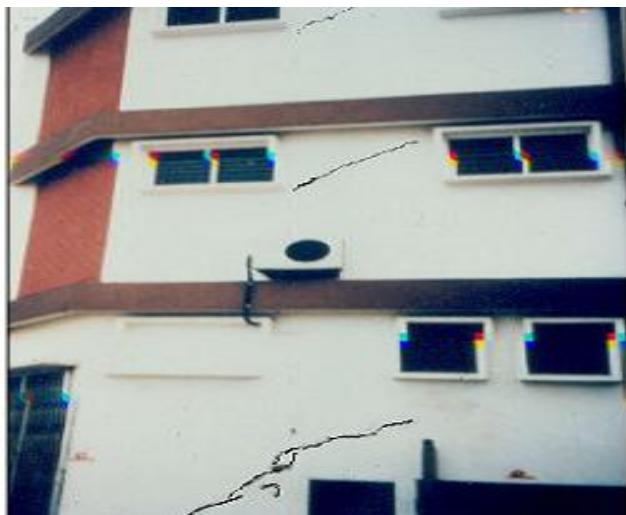
As observed at the site, the final excavation level was mainly at the sandy layer. Dewatering activity within the excavation pit was carried out to facilitate the construction of basement slabs and pile caps. The shop houses around the excavation site had cracked due to excessive differential settlement of the ground. Other than cracks on the brick walls, cracks were also observed on the reinforced concrete beams and columns. On one of the units, the structural cracks were so severe that the structural integrity of the house came into doubt and was declared unsafe for occupation (**Fig. 5**).

Fig. 5. Severe cracks in the external walls of a house, [14]

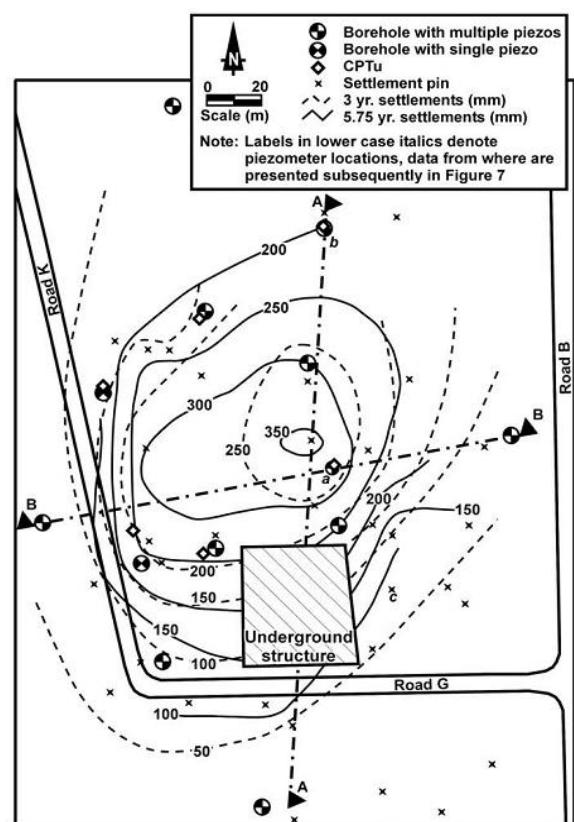
Permanent dewatering for the underground structure resulted in settlements as large as 360 mm within 5.75 years of construction completion. The area affected by settlements extended to distances as far as few hundred meters beyond the perimeter of the structure skewed to the North as shown in **Fig. 6**.

Fig. 6. The project site layout and settlement contours, [15]

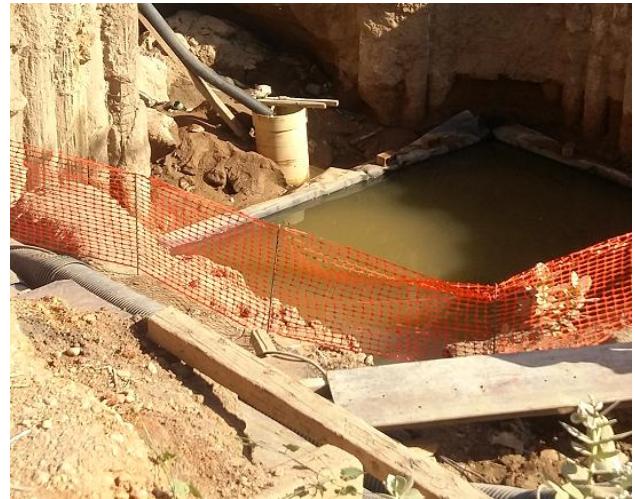
The construction of the station started in 2013 with deep excavation. The contractor started to excavate for the foundation and when the excavation reached close to 7m depth, water started to appear from all directions, filling the site and erode the sandy silt layer at that level creating cavities at excavation sides as shown in **Fig. 7**.

Fig. 7. Water filling the site and erode the excavation sides.

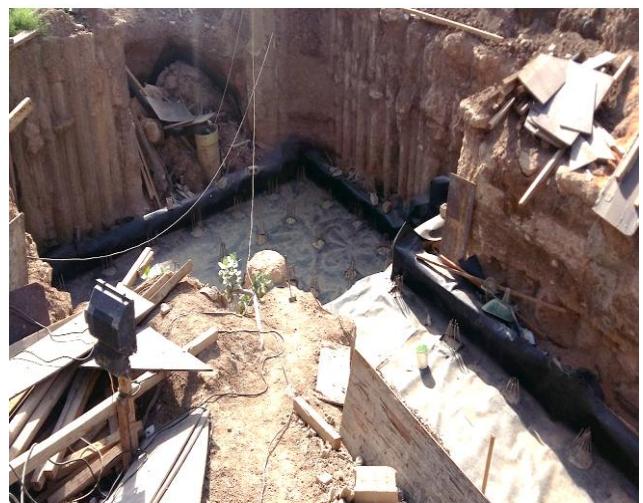
To stop water flow, the contractor started dewatering by pumping water from the excavation pit. Due to presence of sandy silt layer at the excavation sides, earth masses had been sheared and fall down and large cavities created as a result of dewatering (**Fig. 8**). Pumps continuously worked to withdraw water from the site in order to facilitate excavation works. Severe cracks and damages due to differential settlements were clearly observed on the adjacent buildings and road pavement as shown in **Fig. 9**.

The possible causes of the critical situation of the site and the problems resulting from dewatering revealed that no detailed design of dewatering system is used. Inadequate control for ground water level during excavation resulted in sliding and failure of the earth sides; no support is used for the deep excavation like sheet piles to protect the sides from failure; and cavities created in soil layers due to dewatering are a complicated problem which needed making plans before starting any works.

Fig. 8. Falling down of excavation sides after dewatering

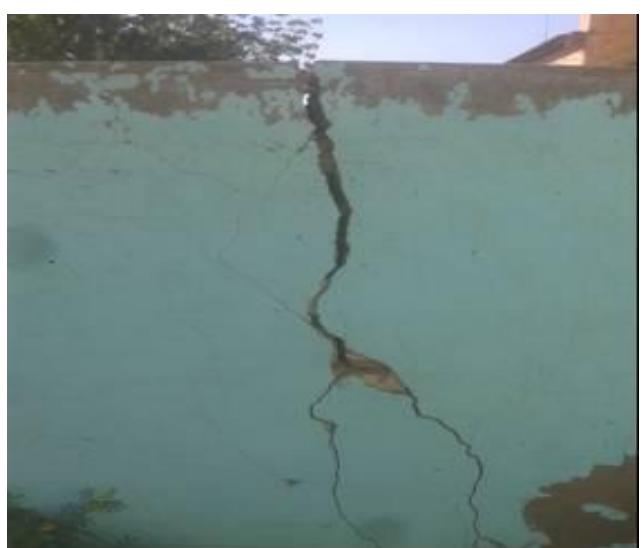
Fig. 9. Serious cracks in walls of adjacent buildings

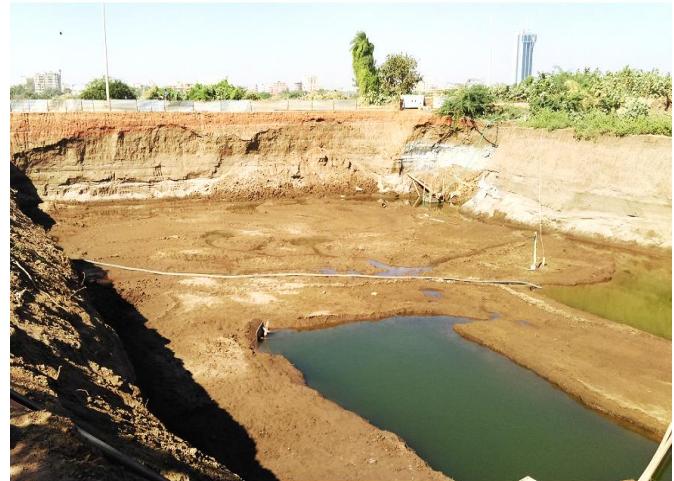
During the basements excavation, water appeared at a depth of 5.3 m below ground level and started to fill the site as shown in **Fig. 10**. The contractor had to start pumping the water in order to continue the excavation work. Sump pumping system was installed to withdraw water by dewatering.

Fig. 10. The project site filled with water before dewatering

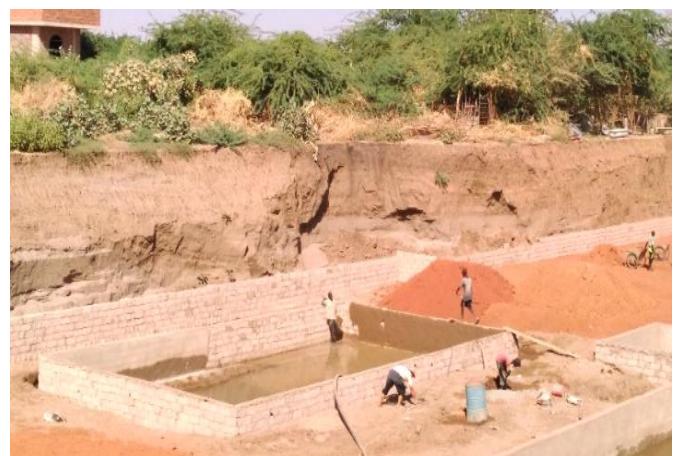
Sliding of the excavation sides of the sand layer was clearly observed on the north and west sides. The contractor used bentonite in some areas of big sliding, but still failing. Large cavities and damaged earth sides were observed after dewatering (**Fig. 11**). The possible causes of these problems at the site may be due to ineffective dewatering system used and excavation sides were not supported to protect them from sliding failure.

Fig. 11. Sliding failure of the excavation sides created large cavities
