A Study on Scour Failure at Bridge Foundation

Magdi M. E. Zumrawi¹, Hassan A. Abusim²

^{1,2}University of Khartoum, Faculty of Engineering,

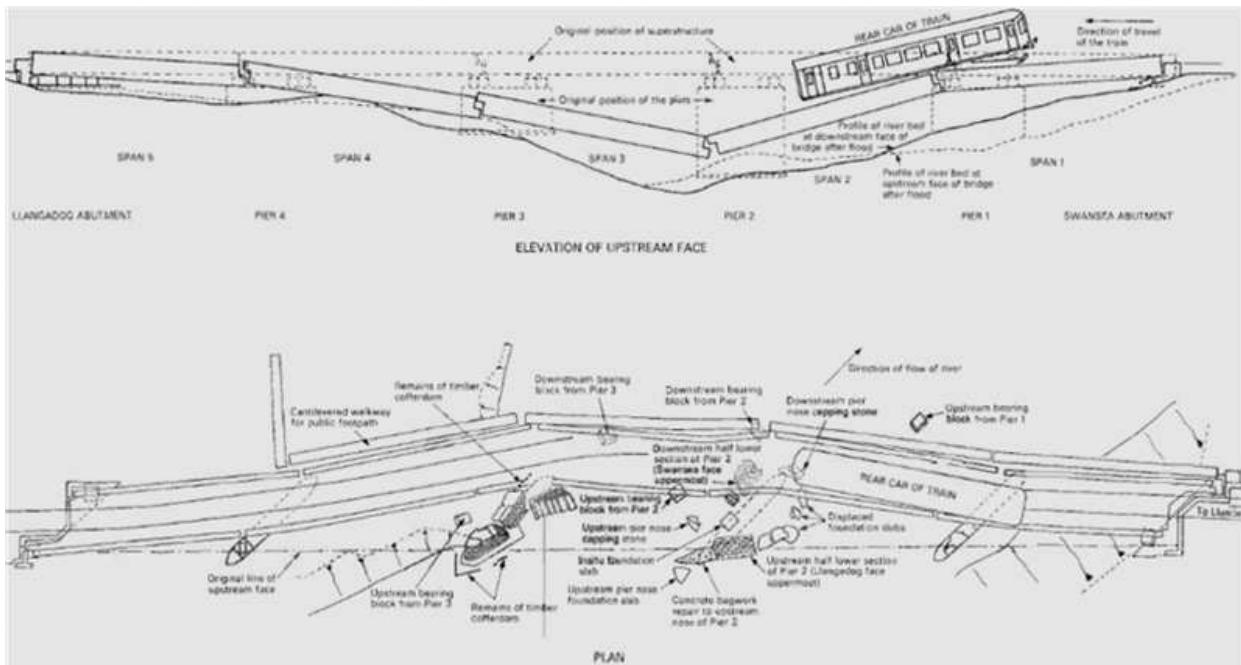
Fig2: Sketch of Glanrhdy Bridge failure [19]

The collapse mainly caused by the scour at the downstream end of pier number 3 that undermined the foundations, allowing the pier to settle and eventually break its back as shown in Fig. 2

The report showed that the pier was originally constructed by driving timber piles to form a cofferdam, making a base for the bridge foundations within the cofferdam of cemented river gravel and then placing stone foundation slabs. Many of the timber piles were missing and this had allowed the undermining to progress below the foundation slabs.

A study of the river flow found that there was a re-circulating zone or eddy at the downstream end of pier 3 and up to 17000 tons of the sediment may have passed the bridge during the three hours of peak flows, indicating a major live bed scour with both erosion and deposition at the bridge. The depth of any anticipated scour at pier 3 could have been between 0.75 and 2.2m depth. It seems that local scour at the downstream end of pier 3 was the main cause of the collapse. Moreover, the remedial works previously carried out to defective bridge piers increased the likelihood of scour damage because the piers were widened and the shape of the cutwaters was changed. Nevertheless, there is the investigators concluded that prior to the collapse there were no visual indications that the bridge stability was in danger.

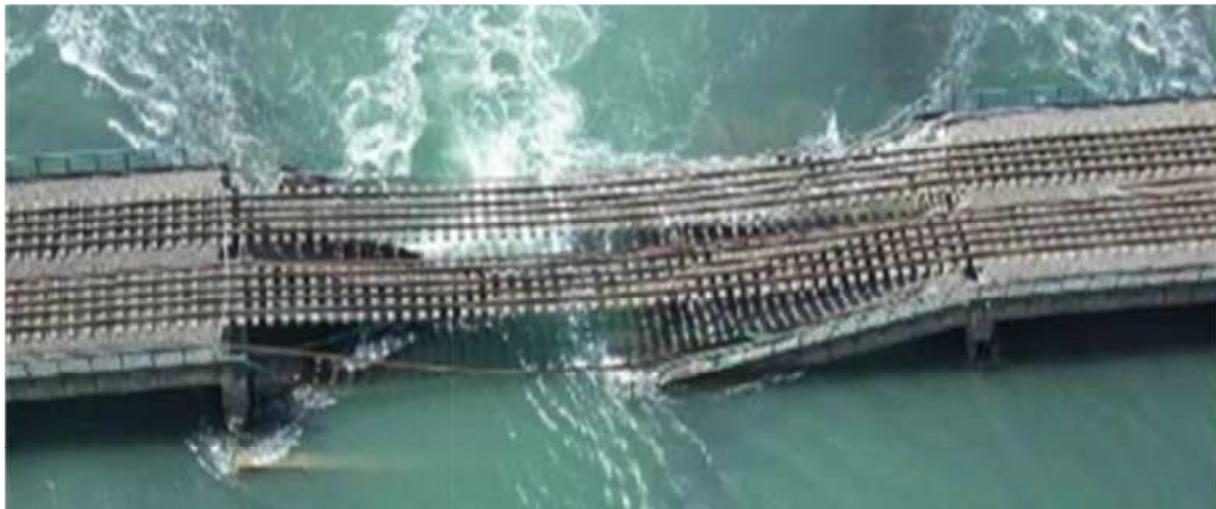
Fig3: Malahide Viaduct Collapse [20]

On 21 August 2009, pier number 4 of Malahide viaduct collapsed into the estuary as shown in Fig. 3. This viaduct carries the main

- The long term gradual elongation of the weir in the ebb tide direction (eastwards);
- The medium term degradation and partial removal of the 1.5m thick layer of grout that extends 1.5m in the flood tide direction (westwards) and 6.1m in the ebb tide direction (eastwards). The propagation of scour to the grouted rock armour weir continued in a westerly direction and was concentrated in between Piers 3 – 5.

- The losses were most severe in between Piers 4 and 5. The concentration of flow in this area resulted in a positive feedback mechanism that increased scour depth and allowed further propagation of the hydraulic jump in a headward direction (westwards);

- The short term propagation of the hydraulic jump, resulting in substantial removal of the grouted and non-grouted rock armour weir material in between Pier 4 and Pier 5 which resulted in the hydraulic jump migrating to a position westward of the bridge piers. The undermining continued in the manner until the invert between piers No 4 and No 5 collapsed, at which time the scour began to undermine pier 4 until it failed.

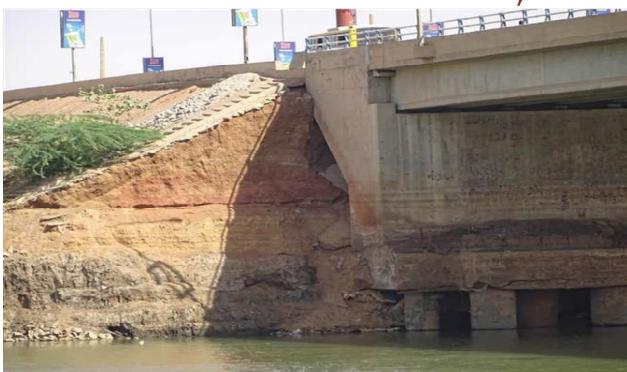
In the year 2015, the flood rate increased to a level more than the normal which lead the soil to wash out around the east abutment as shown in Fig 5. The embankment collapsed due to shear forces on the soil. The piles of the foundation appeared and the soil was washed out around them as shown in Fig. 6. By the end of the autumn season, the embankment around the abutment was completely exposed and the water flow around the piles. Excessive settlement developed in the abutment and the embankment soil escaped down the approach slab as shown in Fig. 7. This situation posed a serious danger to the vehicles and users life on the bridge.

Fig5: Excessive scouring occurred around the east abutment

The investigation shows that heavy floods in Blue Nile River caused scour which extended gradually over time below foundation level. The bridge did not collapse during the high flood period but on receding floods when a heavy tanker passed over the bridge abutment it's approach slab settled and gone way.

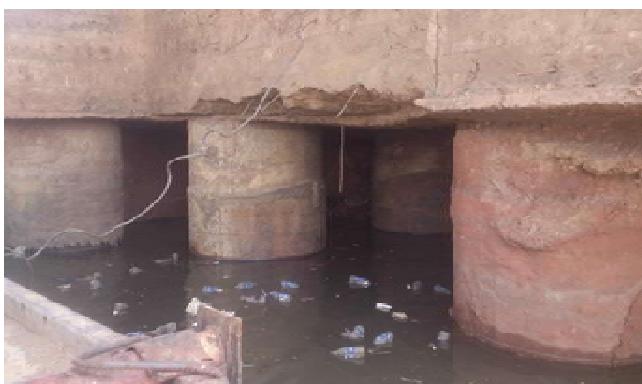
Fig6: The foundation piles surrounded by water

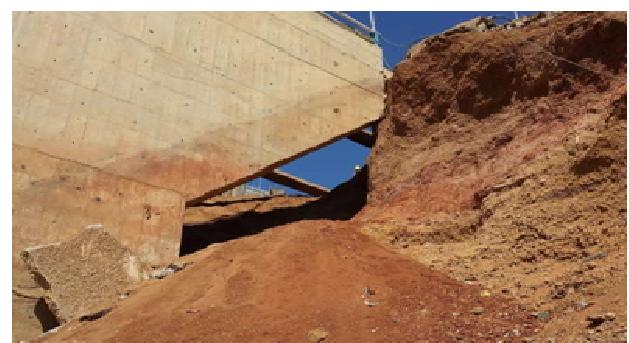
Fig7: Embankment soil escaped away from the approach slab

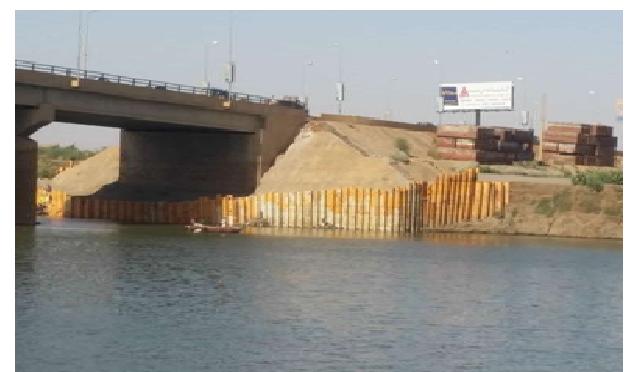
Fig8: Sheet pile installed around the abutment

In Oct. 2014, the ministry of infrastructures decided to maintain the fail abutment. The maintenance started by driven sheet piles inside and around the abutment to carry the approach slab and providing protection for the new embankment. Landfill works of the embankment took place under the approach slab which was protected by Granite stones and covered with a new asphalt layer on the roadway as shown in Fig. 8.

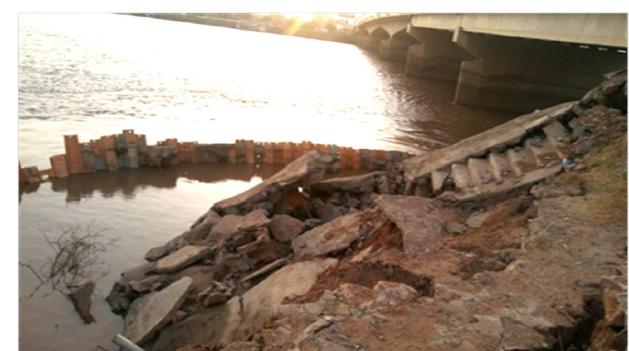
Fig9. Serious failure and collapse of the protection around The abutment

In this research, the bridge was visited to inspect the current situation of the bridge. It was observed as shown in Fig 9 serious failure and damage occurred in the protection made around the east abutment. As can be observed in Fig, complete collapse of the embankments and severe failure happened in the sheet piles surrounding the abutment.

- High Speed flow of Blue Nile river water.
- Since the loose soil scoured with high rate and from the result of the sample which had low plasticity.
- Neglect seasonal inspection and periodic maintenance.
- Taking decision of constructing structures around river without any study it's risk to the hydraulic structures.
