## Visual Indicator-Based Thermal Inference (VITI) for Post-Fire Structural Assessment

<sup>1</sup>Department of Civil Engineering, University of Khartoum, Sudan

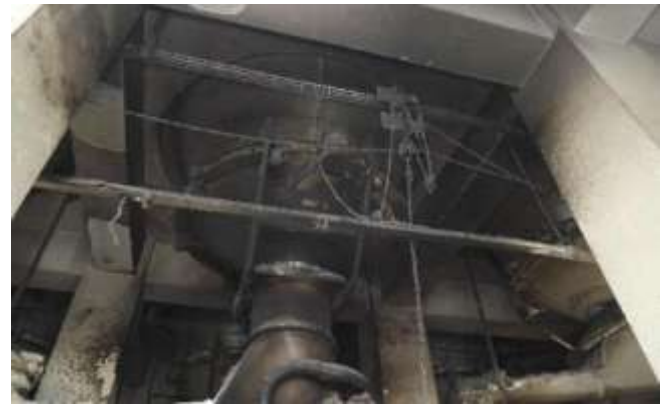
**Figure 5** Wheat flour bins at section B (Explosion Zone)

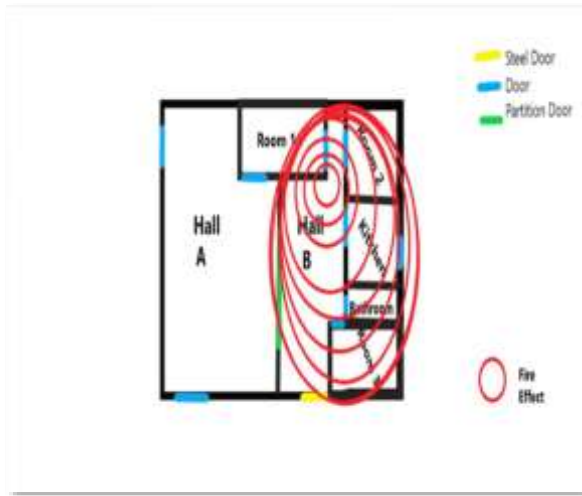
**Figure 9** illustrates the ground floor layout of the affected residential building in Jabra, Khartoum and highlights the spread of fire effects. The concentric red circles represent decreasing heat intensity from the assumed fire origin point on Hall B, with areas such as Room 2, the Kitchen, Room 3 and the steel door area suffering higher fire exposure based on observed damage mentioned before.

**Figure 9** Fire and heat exposure zones in the Jabra Residential Building ground floor layout

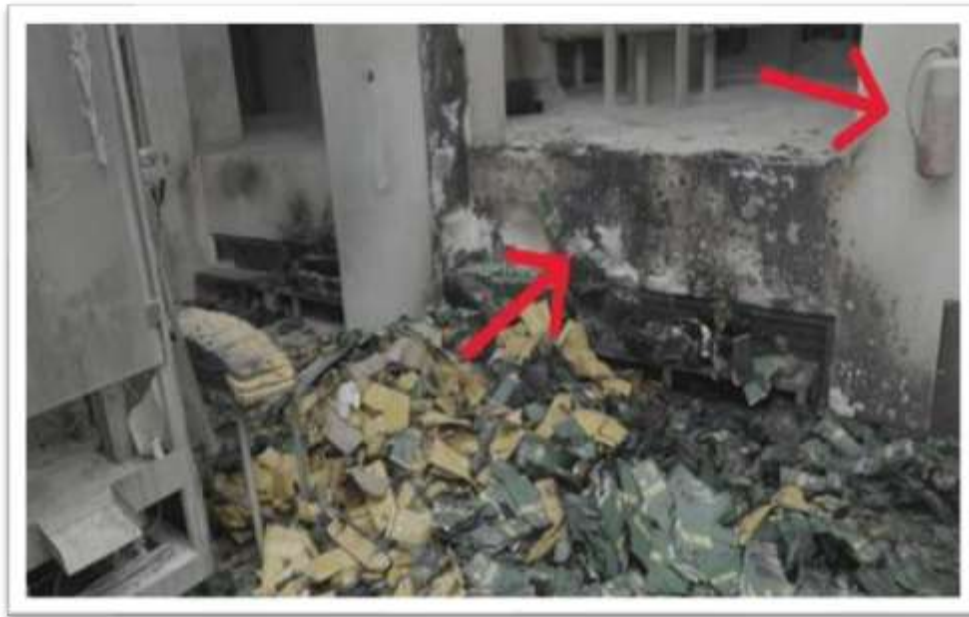
| Category | Indicator | Location / Zone | Implication/VITI |
|---|---|---|---|
| Paint/ Finishes | Paint blistering, soot and bubbles ( <b>Figure A .3</b> ) | Concrete members near the flour bins | Paint destroyed at ~150 °C ( <b>Table A. 4</b> ); soot deposits indicate fire exposure; there was no evidence of any crazing or concrete spalling, which indicate that structural integrity of the concrete was not degraded by the fire; temperature in this area most likely not more than 150 °C. |

**Figure A .4: Destroyed paint of concrete members adjacent to flour bins [24]**

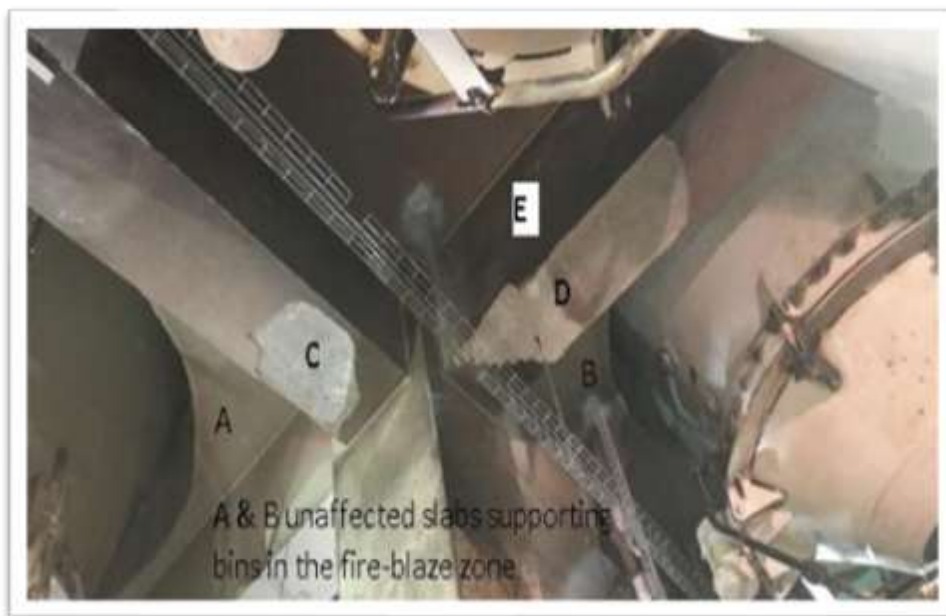
| Category | Indicator | Location / Zone | Implication/VITI |
|---|---|---|---|
| | Concrete colour remained grey, limited superficial spalling ( <b>Figure A .1</b> ) | RC slabs and columns near blaze zone | Plaster Spalling ( <b>Table A. 1</b> )( <b>Table A. 2</b> ) and didn't exceed to surface spalling in concrete member, and all members were intact. The concrete colour underneath the plaster was normal grey colour. No major strength loss, temperature in this area most likely <b>not more than 300 °C</b> . |

**Figure A .5: General view for the fire-blaze zone [25]** A and B the unaffected slabs supporting flour bins; C & D exhibited spalled plasters of beams; E shows the black soot on the plaster [31]

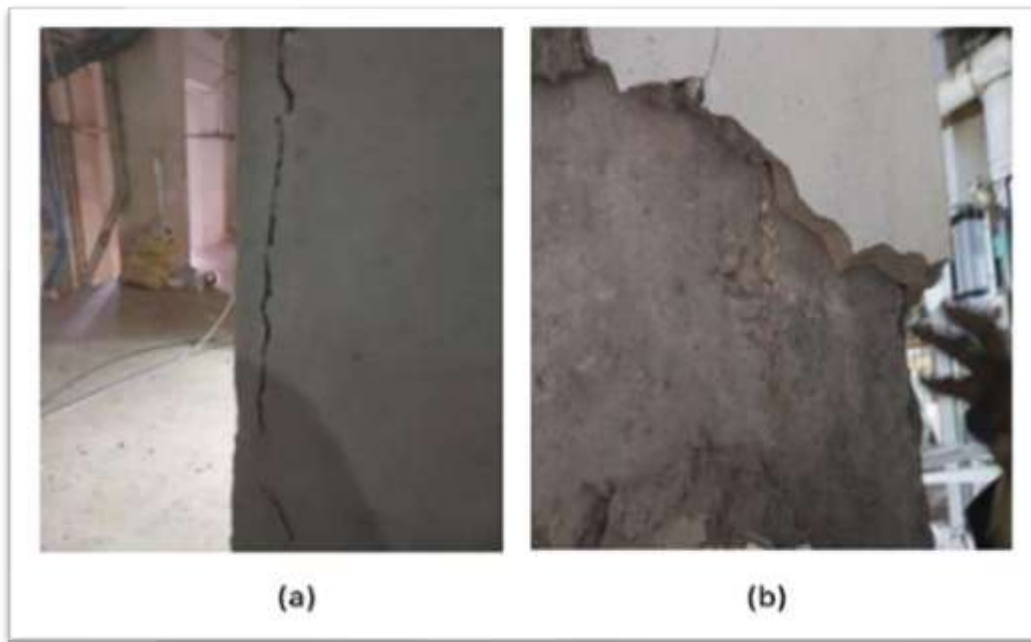
| Category | Indicator | Location / Zone | Implication/VITI |
|---|---|---|---|
| RC | Plaster crack at RC Column supporting the bins ( <b>Figure A .3</b> ) | Column which supporting the bins | Plaster detached, underlying concrete unaffected by any kind of cracking or spalling and the concrete colour was normal grey colour, temperature in this area most likely <b>not more than 300 °C</b> . (This observation coincides with the RHT and UPV results carried out by UKCC team) |

**Figure A .6: Plaster crack at RC Column supporting the bins [25]**  
(a) before removal of plaster; (b) after removal of plaster to ensure the RC column that shows the structural concrete is intact [31]

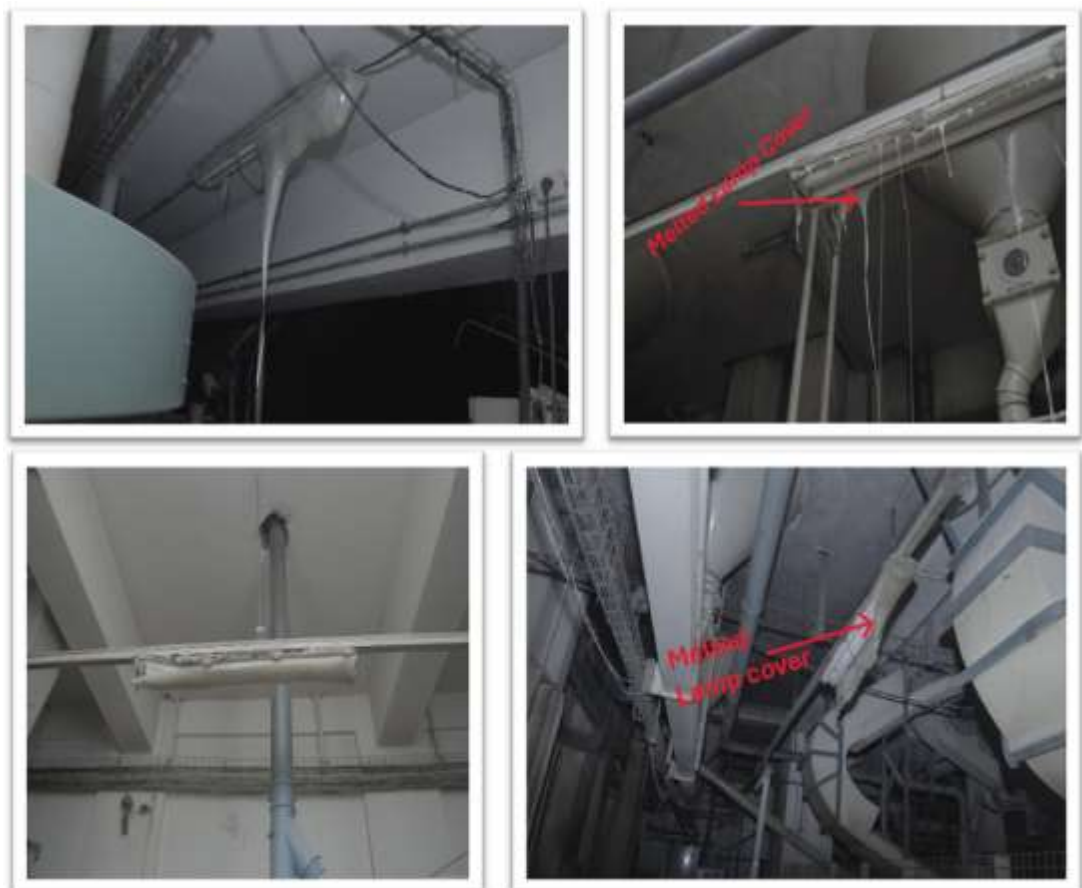
**Figure A .7: Melting without ignition of the lamps plastic cover [25]**

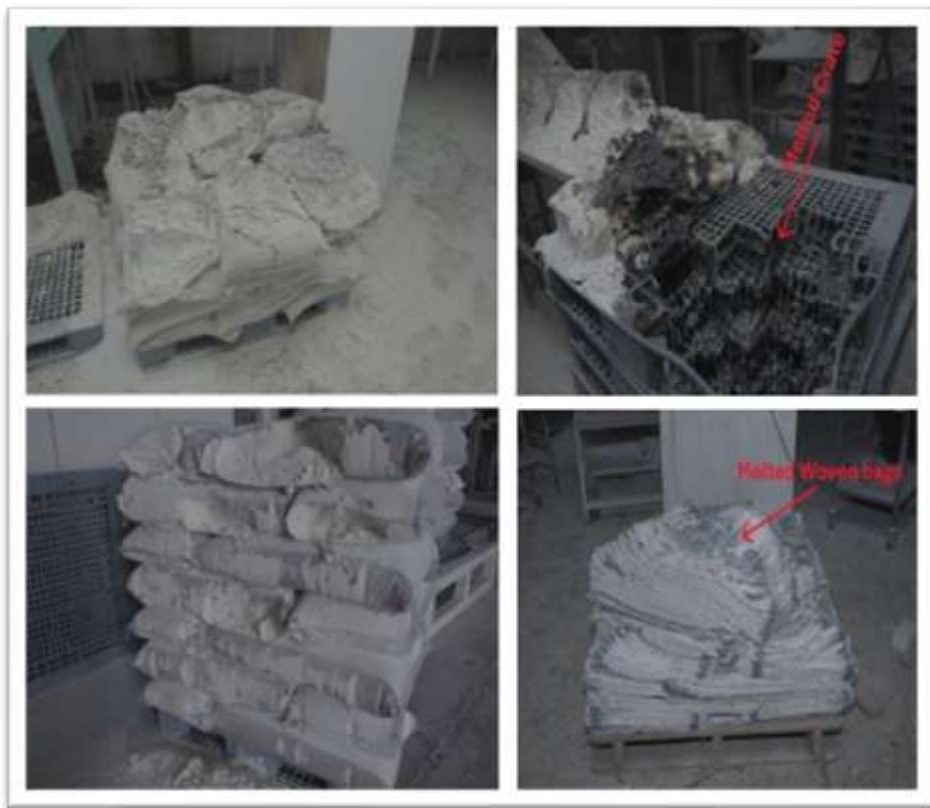
**Figure A .5: Melted crates and wheat woven bags without flour ignition [25]**

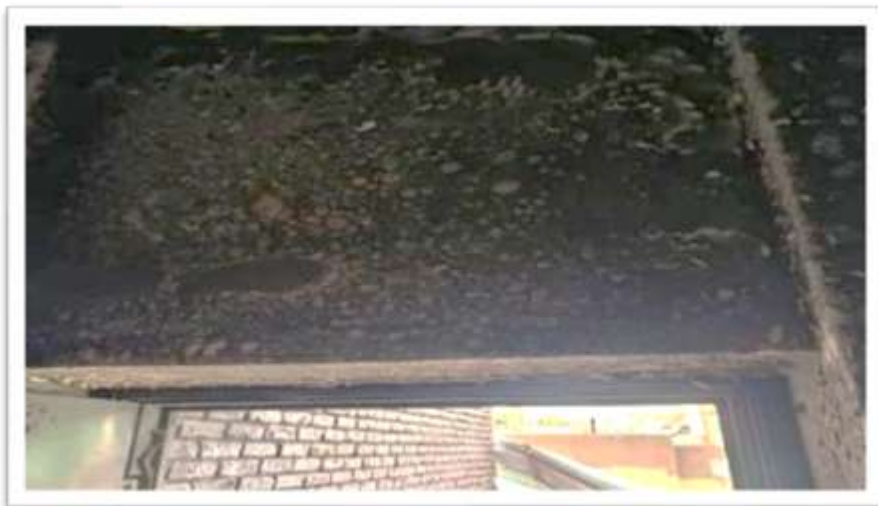
**Figure A .6: Bubbled paint with soot above the steel door**

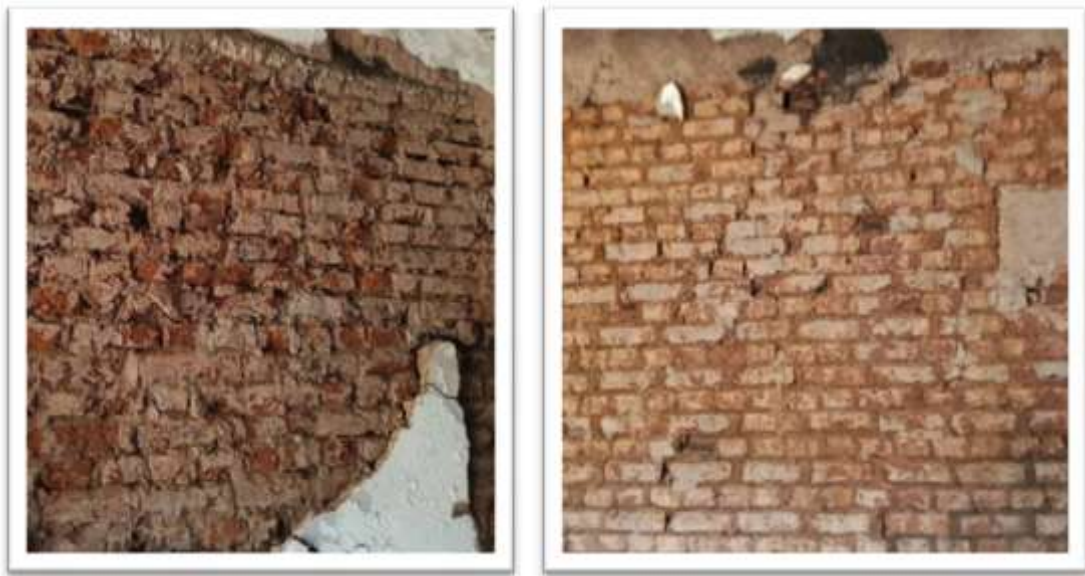
| Category | Indicator | Location/zone | Implication/VITI |
|---|---|---|---|
| Masonry<br>(Brick &<br>Mortar) | Exposed brick masonry<br>intact with plaster<br>spalling ( <b>Figure A .7</b> ) | Room 3<br>Walls | Plaster spalling only; bricks intact (no missing outer corners), damage largely cosmetic. Bricks start to lose strength when exposed to temperatures between (~200-400 °C) ( <b>Table A. 4</b> ), temperature in these areas was most likely <b>not more than 400 °C</b> . |

**Figure A .7: Exposed brick masonry with relatively intact structure and plaster spalling at different parts inside room 3**

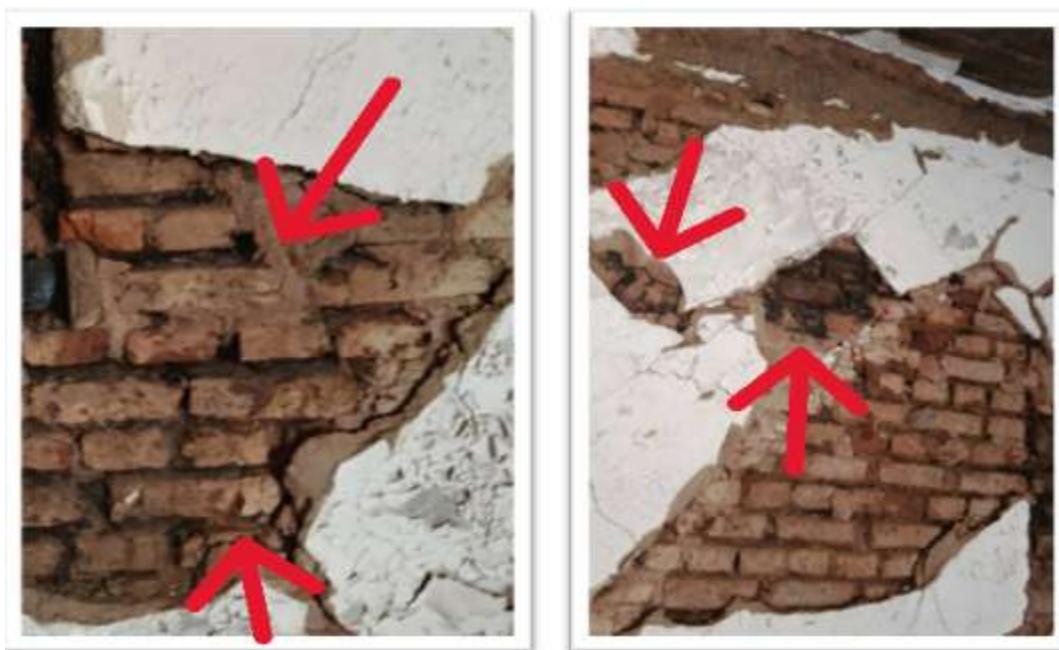
**Figure A .8: Discoloured mortar joints in brick walls of room 3**

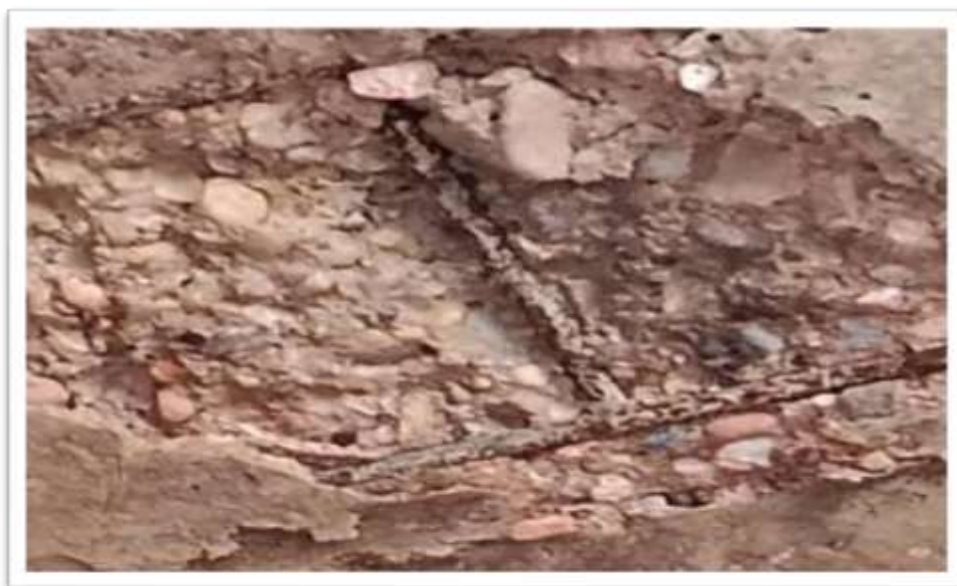
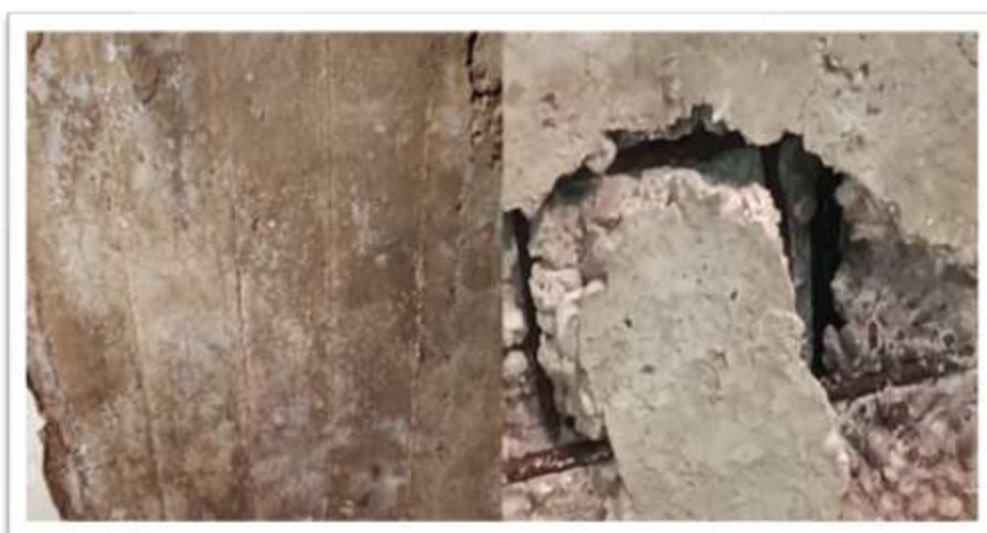
| Category | Indicator | Location/zone | Implication/VITI |
|---|---|---|---|
| RC Mem-<br>bers | RC slab spalling, ex-<br>posed aggregate and re-<br>inforcement; whitish<br>patches ( <b>Figure A .9-<br/>Figure A.10</b> ) | Room 3 Slab | Medium spalling (Table A. 1); moderate damage (Table A. 2). Whitish patches are interpreted as likely durability-related (pre-existing moisture ingress, carbonation, or salt deposits) rather than fire-induced discolouration. This interpretation is supported by the following observations: (1) the whitish patches are localised and not uniform across the fire-exposed area, which would be expected if caused by high-temperature exposure above 600 °C; (2) the surrounding concrete retains its original grey colour with no pink or red discolouration indicative of 300-600 °C exposure; (3) visible reinforcement corrosion in these areas suggests long-term moisture presence. However, the authors acknowledge that literature often associates whitish/grey concrete with high-temperature exposure (above 600 °C), and this interpretation requires confirmation through supplementary testing such as the phenolphthalein indicator test or core sampling, temperature in this area may have locally <b>reached or somewhat exceeded 300 °C</b> . <sup>34</sup> |
| | Corroded reinforcement noted around<br>spalled regions ( <b>Figure A .9 - Figure A.10</b> ) | Room 3 Slab | Interpreted as pre-existing durability problem (Moisture/Carbonation), likely contributed to spalling extent ( <b>Table A. 5</b> ) ( <b>Table A. 6</b> ), but there is no change in slab concrete colour, temperature in this area was most likely <b>not more than 300 °C</b> . |

**Figure A .9: Spalling occurred in RC slab in room 3**

**Figure A .10: RC slab with localized spalling and visible patches of whitish discoloration in room 3**

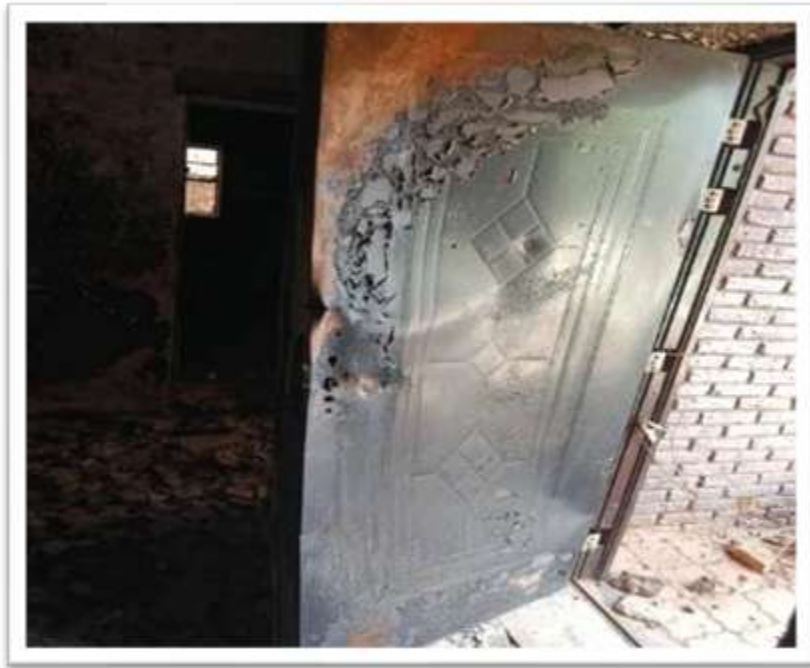
| Category | Indicator | Location/zone | Implication/VITI |
|---|---|---|---|
| | Steel door with coating<br>deterioration; surface<br>oxidation visible ( <b>Fig-<br/>ure A.11</b> ) | Steel door<br>area | Paint/Powder coat (usually Polyester/Epoxy-based powder) blistered/peeled ( <b>Occur at~250-300 °C</b> ), steel intact and structurally sound (steel has no strength reduction up to 400 °C at which surface oxidation (Rust) begins). Temperature in this area <b>most likely not more than 400 °C</b> . |

**Figure A .11: Metal door with maintained overall integrity and coating deterioration**

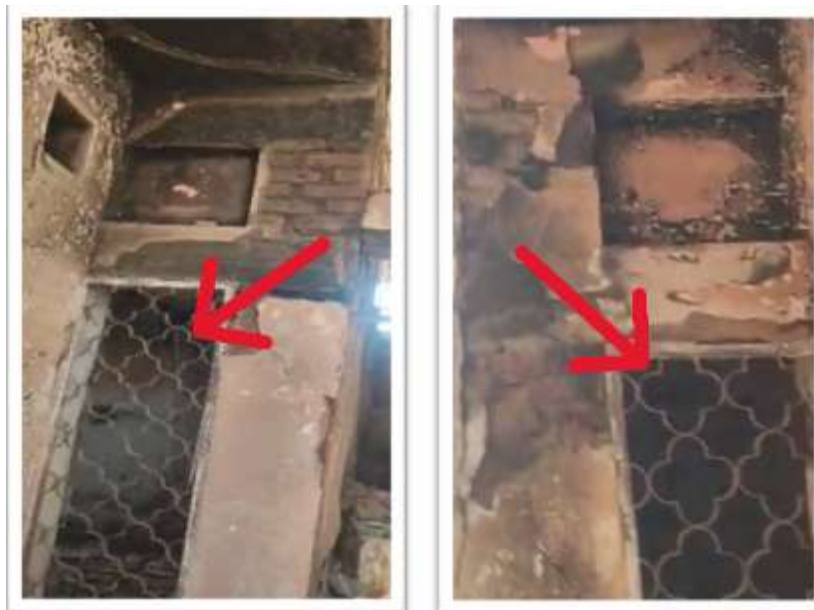
| Category | Indicator | Location/zone | Implication/VITI |
|---|---|---|---|
| | Metal grill & window<br>frame with soot de-<br>posit, no distortion<br>( <b>Figure A.12</b> ) | Window<br>opening area | Small/thin soot layer; no bending/deformation, no rusting, steel did not reach its melting or oxidation point (No Rusting), temperature was hot enough to destroy paint but did not affect small steel section. Temperature in this area <b>most likely not more than 400 °C</b> . |

**Figure A.12: Metal grill and window frame with soot deposit with no distortion**

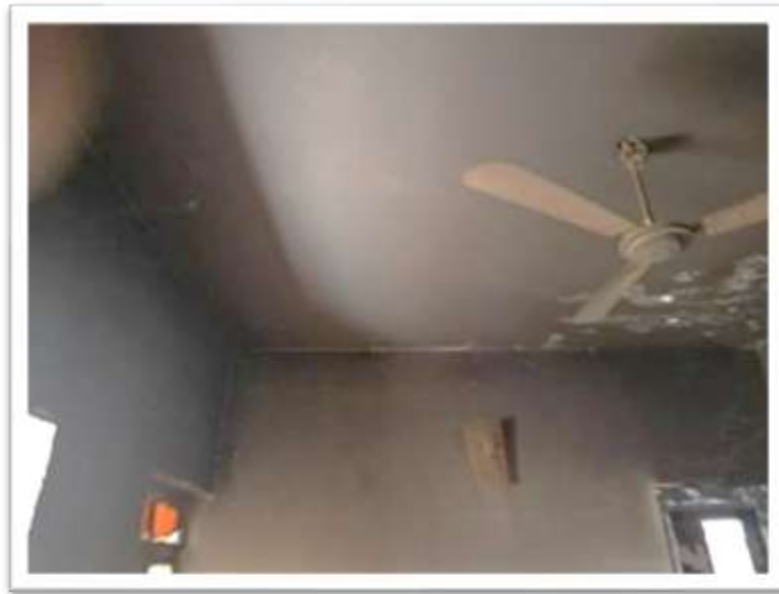
**Figure A .13: Ceiling fan mounted at the centre of the room 1 with visible soot but no apparent distortion**

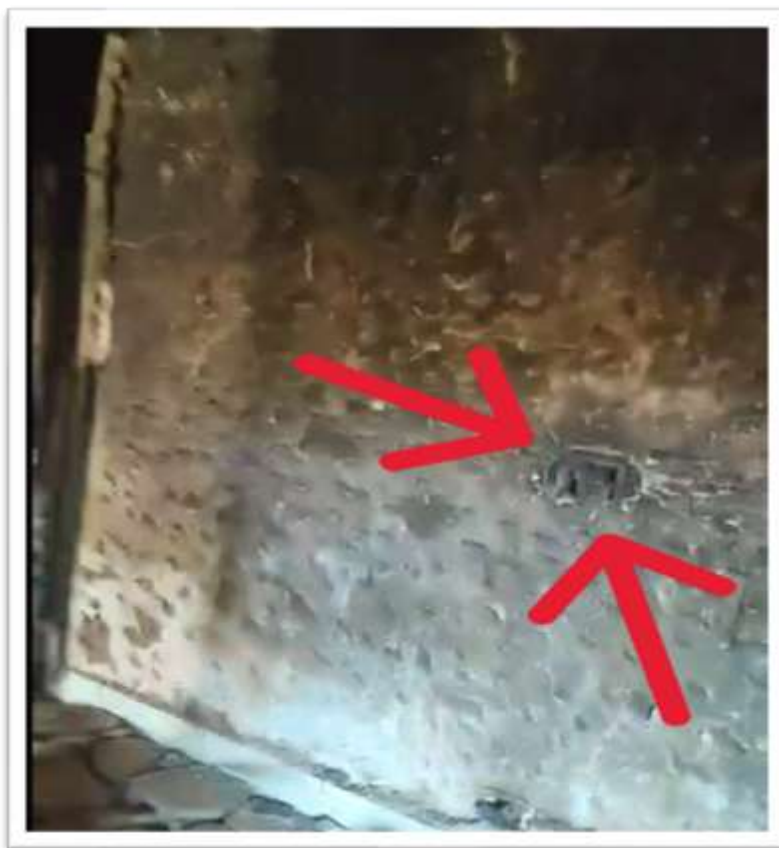
**Figure A .14: Melted electrical switch cover in kitchen area**

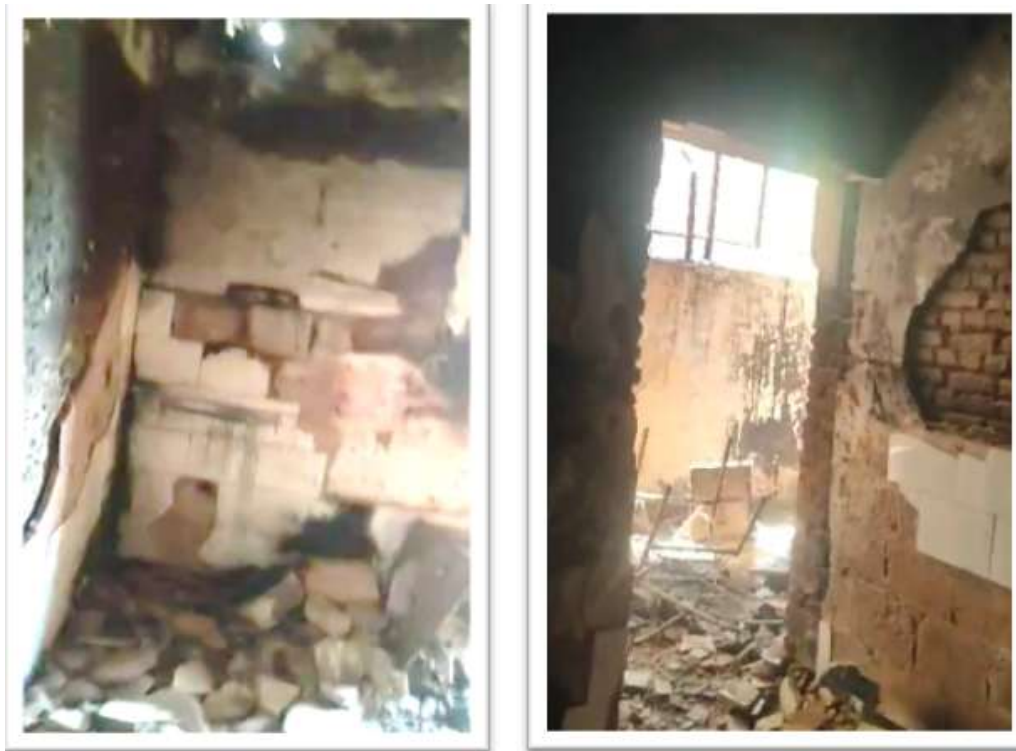
| Others | Kitchen walls with exposed bricks; fallen plaster/tiles; extensive finish loss (Figure A .15) | Kitchen | Pattern more consistent with sudden loading (Pressure wave) followed by fire; possible gas cylinder (Unconfirmed). |

**Figure A .15: Kitchen area showing significant structural damage with characteristics most likely consistent with explosion and fire effects**

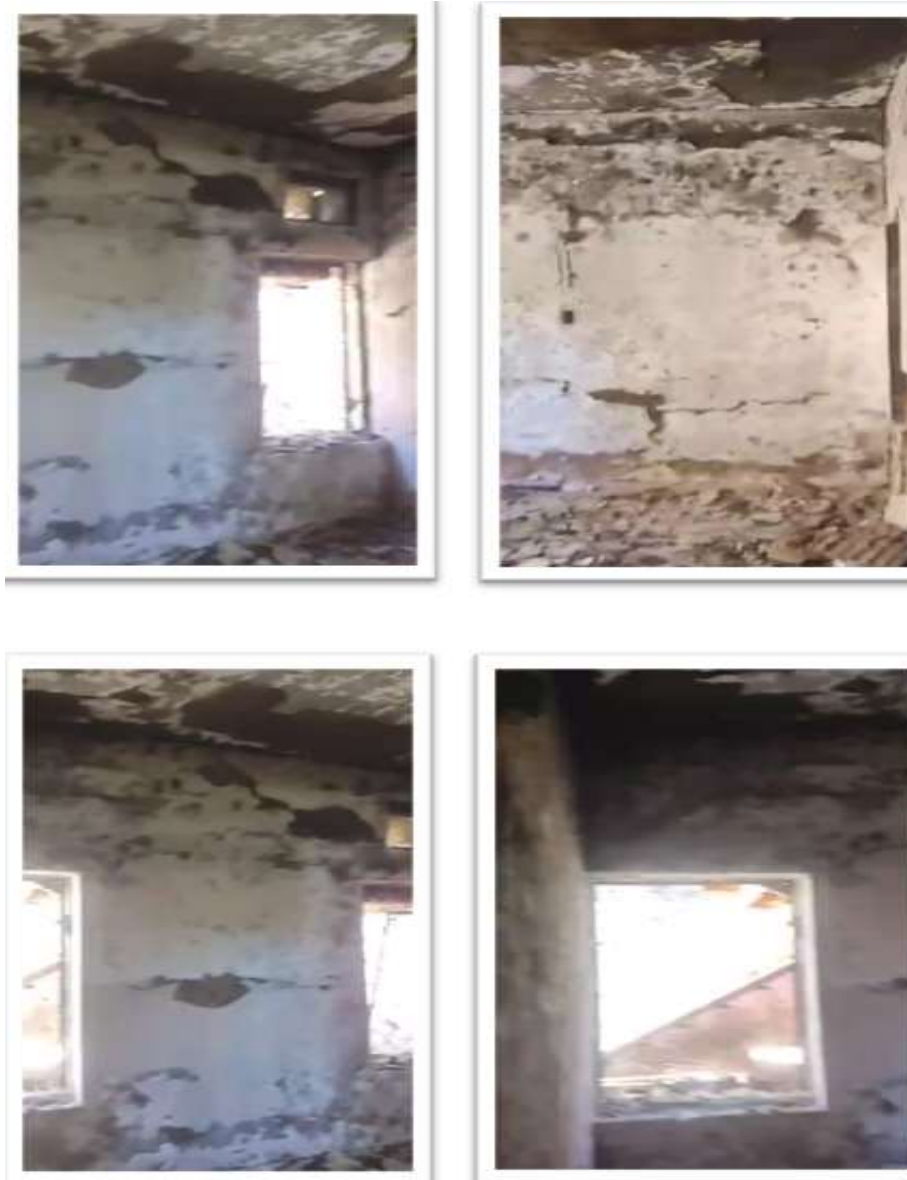
| | Room 2 with plaster & paint damage (photos from video only) (Figure A .16) | Room 2 | Insufficient clear photos; authors recommend further assessment and site verification. |

**Figure A .16: Photos captured from video of room 2 showing plaster and paint damage with further assessment needed**
