# INFLUENCE OF ANODIC ANGLES ON CORROSION CRACK PATTERN IN REINFORCED CONCRETE

*Afra Omara<sup>1</sup>, Amged O. Abdelatif<sup>2</sup>*

<sup>1&2</sup>Department of Civil Engineering, Faculty of Engineering, University of Khartoum,

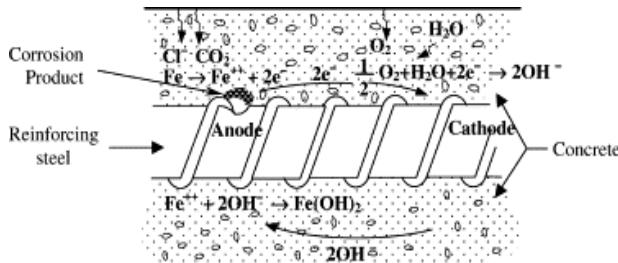
Figure 1: Electrochemical process of corrosion in concrete[6]

The corrosion of the reinforced concrete is an electrochemical process. The process involves two chemical reactions at two different locations on the steel surface. To proceed the reactions; an electrical current must flow in a closed loop. The two reactions are known as “anodic” and “cathodic” reactions, and they occur at “anodic” and “cathodic” areas respectively. Figure 1 shows the corrosion Electrochemical process [5].

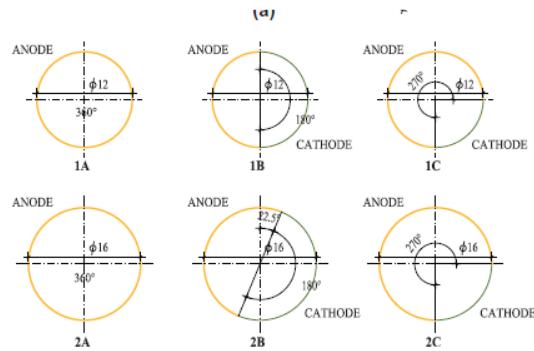
Figure 2: Anodic and Cathodic angles for two groups[9]

The 3D chemo-hydro-thermo mechanical model is used to study of the pull-out of the reinforcement bar from the beam-end specimen [9]. The study investigated the influence of anodic angle along the reinforcement bar in the corrosion crack pattern with three different anodic angles (360,180 and 270) as shown in Figure 2.

The results show that the most realistic crack pattern is obtained for the case where the half of the bar surface (i.e.180°) in comparison with the experimental results.

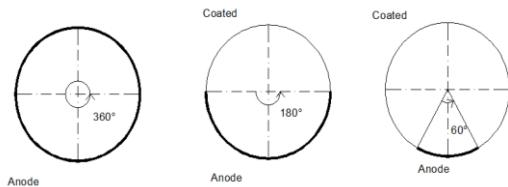
**Figure 3: Anodic angles along the cross-section of the reinforcement bar**

The first sub-group was free of anti-corrosion coating to give an anodic angle of 360° (G 100-360), the second and third sub-groups were coated to give an anodic angle of 180° (G 100-180) and 60° (G 100-60) respectively as shown in Figure 3. The steel reinforcement of all cylinders was provided at a cover of depth 35 mm from bottom.

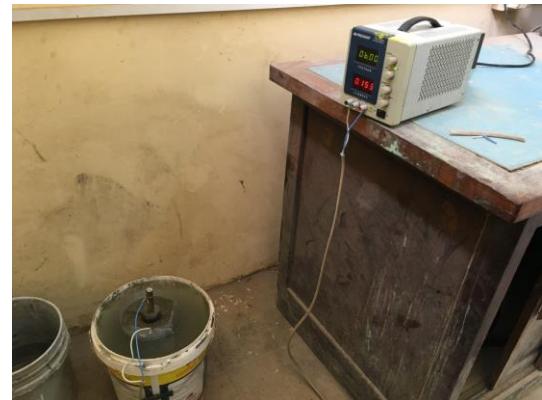
**Figure 4: Accelerated corrosion test setup**

In the present study, the accelerated corrosion test using impressed voltage technique was used. A potential of 12 V (DC power supply) was applied across the tested cylinders [11]. The reinforcement steel bar of the concrete cylinders was connected to the positive terminal

and stainless steel mesh was connected to the negative terminal of the DC power supply. In this research, steel mesh was used to insure an equally sides flow of current. Both cylinder and stainless steel mesh were partially immersed in 5% NaCl solution for first group samples and the dosage increased to 10% for the second group samples. Figure 4 shows the accelerated corrosion test setup.

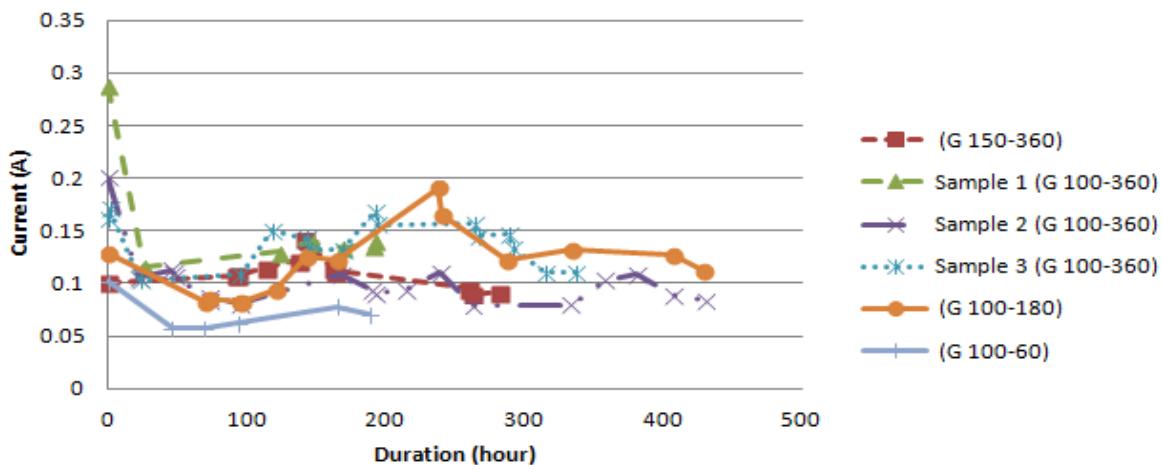
Figure 5: Current-Time relationship for all samples

Current-time relationships for all reinforced concrete samples of all groups are shown in Figure 5.

Decreasing in current is noticed in sample (G 150-360). The cathode at this test setup has to be a stainless steel mesh or plates to insure that the rust will form at the anode and therefore causing the cracking of concrete [11]. The increasing in current is corresponding to growth of crack and therefore decreasing in electrical resistance [11].

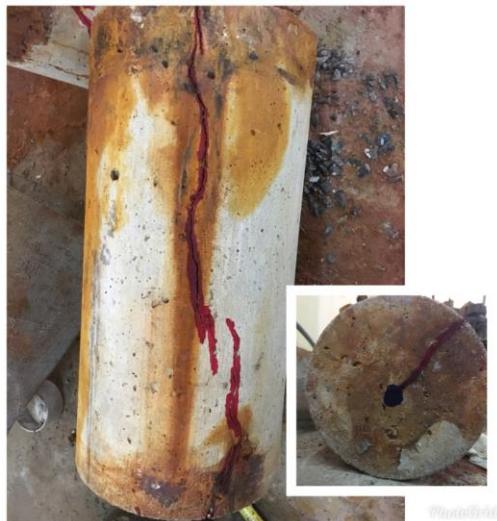
Figure 6: G 150-360 sample Crack pattern

Crack pattern for the second sample of G 150-360 is shown in Figure 6. The crack starts from the upper part of cylinder down to the lower part.

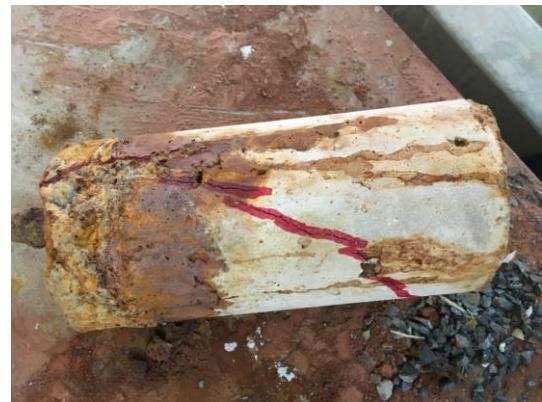
Figure 7: G 100-360 sample 1 Crack pattern

The first and second sample of group G 100-360 the corrosion happened at the upper part of rebar. As a result of that, no increase in current is noticed. The crack patterns for the two samples are shown in Figure 7 and 8 respectively. Also the crack starts from the upper part of cylinder down to the lower part.

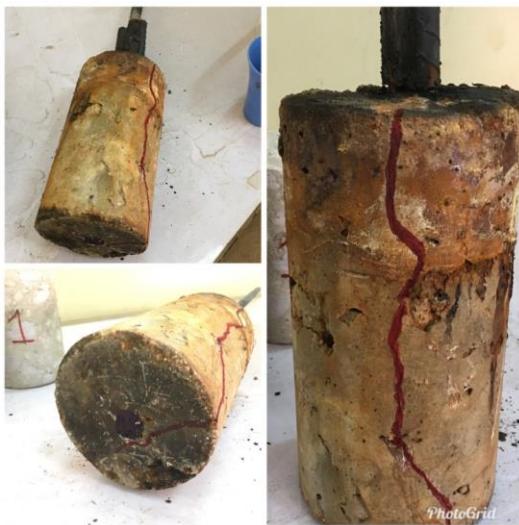
**Figure 9: G 100-360 sample 3 Crack pattern**

It can be noticed from this group that the time of crack initiation is less than the time of crack initiation in G 150-360. This means that the concrete cover have strong influence on the time of crack initiation. The crack pattern for this sample is shown in Figure 9.

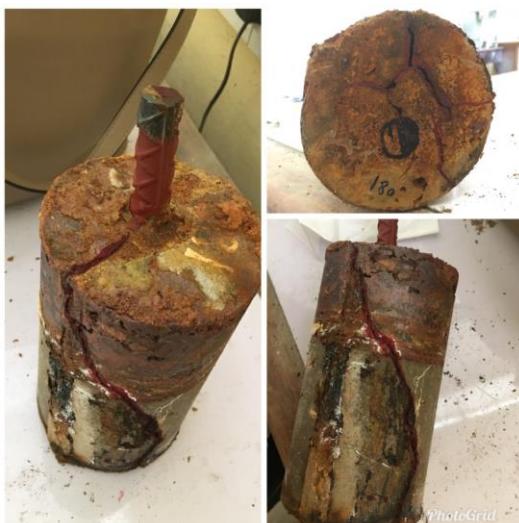
**Figure 10: Crack pattern of G 100-180 sample**

The crack pattern for sample 1 of (G 100-180) starts from the top of cylinder at the un-coated side of rebar. And the crack continues in aligned direction down to the lower part of cylinder near to the coated side of rebar as shown in Figure 10.

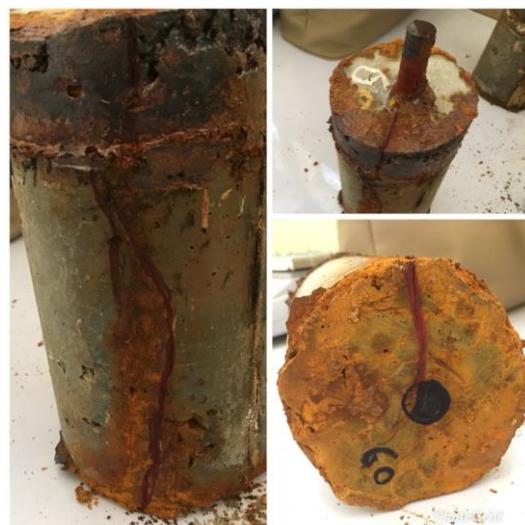
**Figure 11: Crack pattern of G 100-60 sample**

The crack pattern for sample 1 (G 100-60) is also starts at the upper part of cylinder near the un-coated side of rebar and continues perpendicularly to the lower part of cylinder as shown in Figure 11.

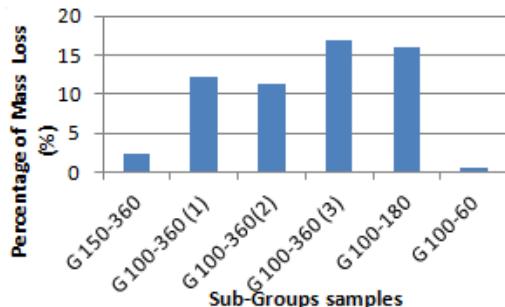
Figure 12: Percentage of Mass Loss (%) for all samples

Figure 12 shows the percentage of mass loss (%) for all samples. It can be obvious from this figure that the higher percentage of mass loss obtained from sample with anodic angle of 360° and small concrete cover. No significant difference from the higher value was noticed for the sample with anodic angle of 180°.

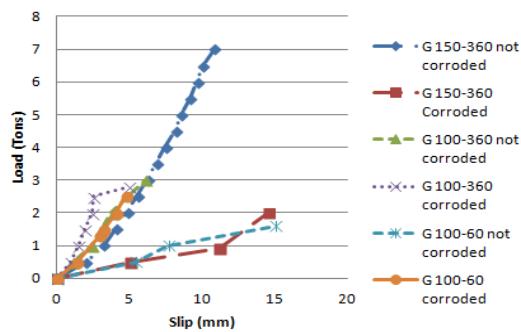
Figure 13: Load-slip relationship for all samples

Load-slip relationship for all samples of G 150-360, G 100-360 and G 100-60 are shown in Figure 13. No records for the corroded sample of G 100-180 because it failed before applying the pull out test. All cylinders loaded up to failure (pulled-out).

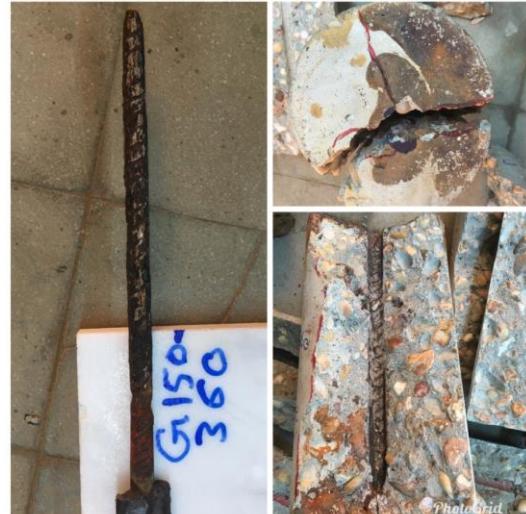
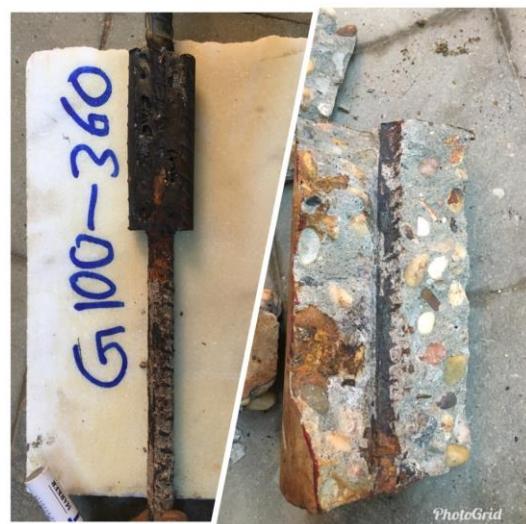
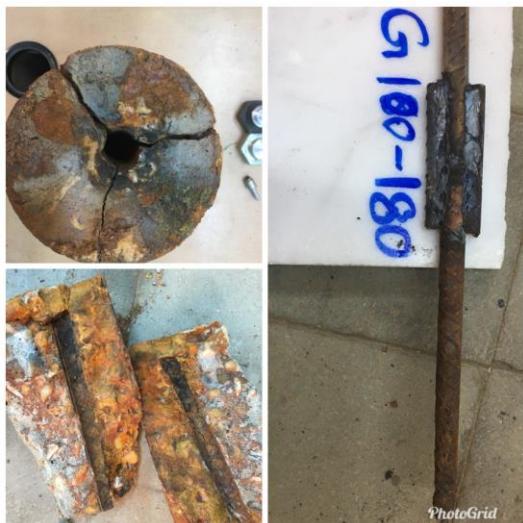
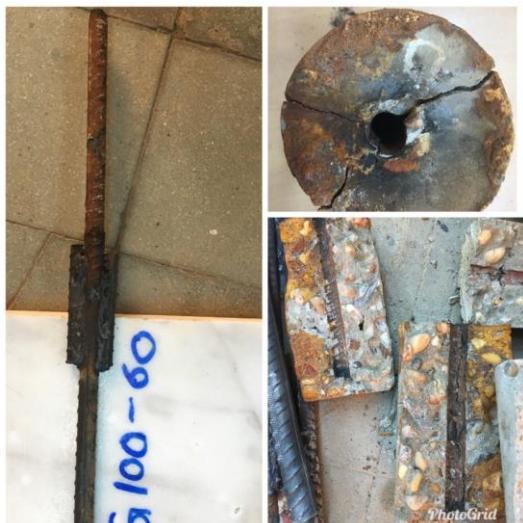
The corroded rebar and failed cylinders of all tested samples of G 150-360, G 100-360, G 100-180 and G 100-60 are shown in Figures 14, 15, 16 and 17 respectively.

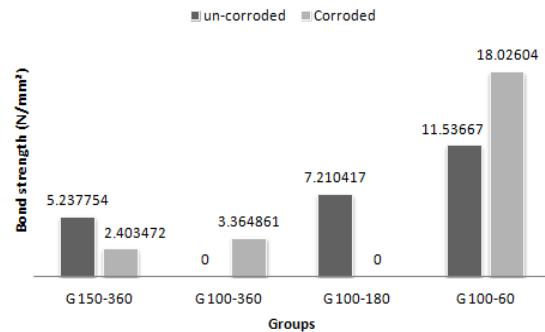
**Figure 18: Bond Strength for all tested samples**

The results of bond strength calculation for all tested samples were illustrated in Figure 18.

From the above chart it can be noticed that bond strength increases with the decreasing in anodic angles (whether for corroded or un-corroded samples). For the samples of G 150-360 the bonding strength for the un-corroded sample is higher than the corroded sample. But for G 100-60 the accelerated corrosion test duration was less than the other samples, therefore the bonding strength for the un-corroded sample is less than the corroded sample. This means that the corrosion decreases the bond strength for later stages of corrosion and increases to bond strength for early stages of corrosion. This was discussed previously in the introduction [7].
