## Assessing the Pavement Quality of National Roads in Sudan

Magdi M. E. Zumrawi

Department of Civil Engineering, Faculty of Engineering, University of Khartoum

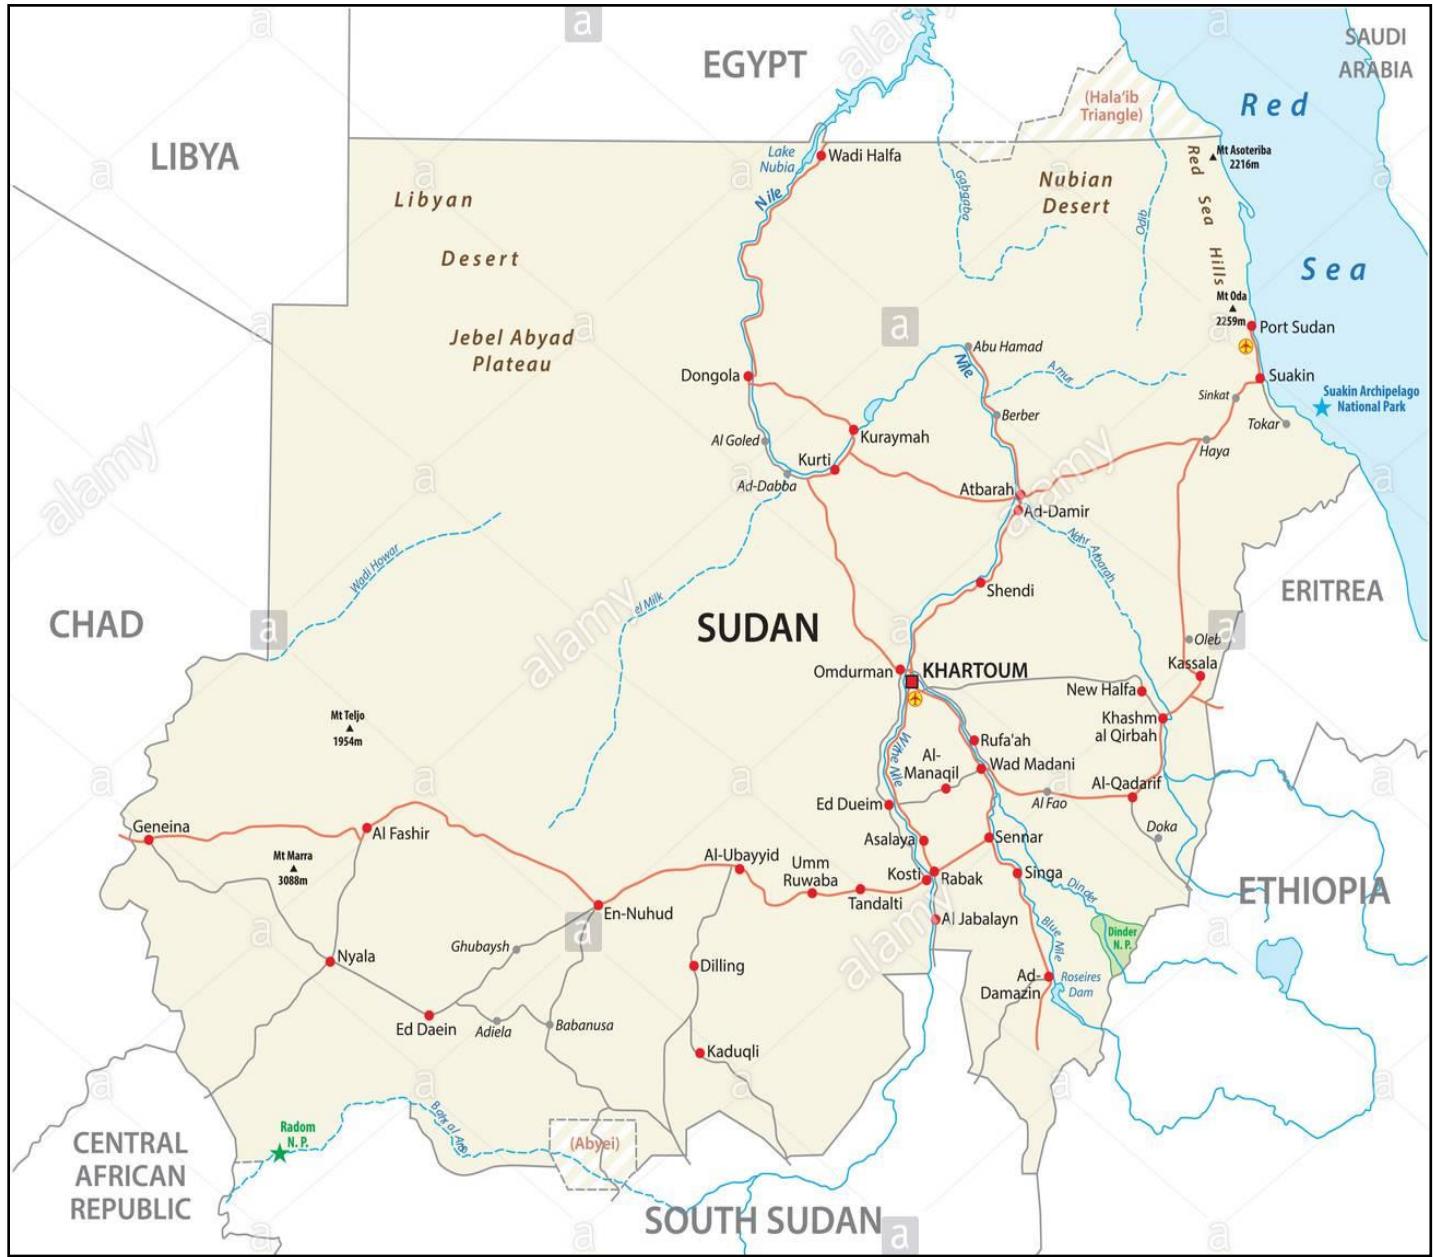
Fig.1. Map of the national road network in Sudan

The wide area of Sudan is covered by the national road network that connects the states of Sudan. The technical report issued by the National Roads and Bridges Authority [1] showed that the total length of the network is about 30,000 km, of which only 20% are paved. The network is divided into two groups as shown in Figure 1.

The most important national roads in Sudan as shown in Figure 1 are:

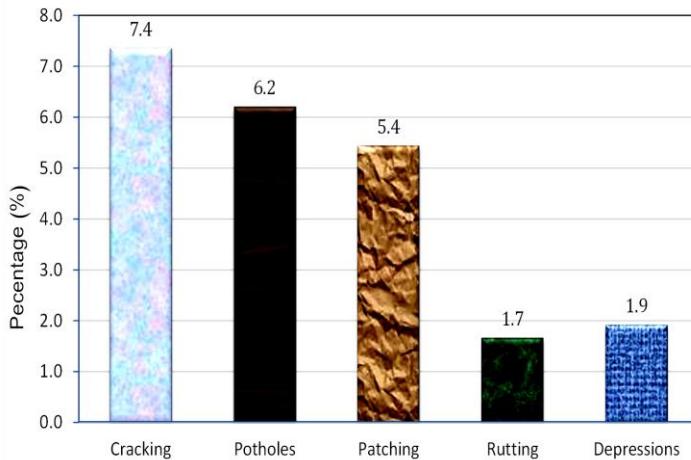
**Fig. 2.** The distresses types and percentages of distresses on the surveyed roads

And by comparing it with the total area of pavement sections, the distress percentage can be calculated. The types and percentages of roads' distresses are plotted in Fig. 2. In this figure, it can be observed that cracking, potholes and raveling have high percentages, 7.4%, 6.2%, and 5.4% respectively. On the other hand, rutting and depressions are minor distresses with low percentages, 1.7% and 1.9% respectively.

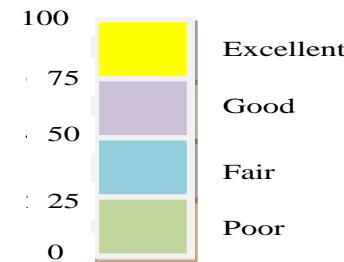
**Fig. 3.** The Pavement Condition Index (PCI)

It is necessary to use a new concept to assess the quality of road pavement based on its condition. The Pavement Condition Index (PCI) was developed to determine a number for each surveyed road according to the pavement condition, average percentage and severity level of observed distresses. The PCI is defined as a numerical indicator that classifies the pavement condition. The proposed scale is assumed to determine the current observed pavement condition on the road. The description of the alignment condition is a function of the PCI value which represents the lowest value of "PCI" from 0 to 25 the "poor" alignment and the highest value of the PCI from 75 to 100 is the "excellent" alignment, as shown in Fig. 3.

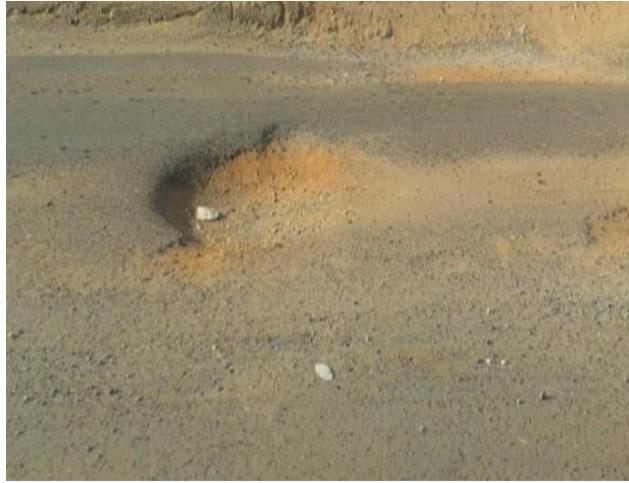
Fig. 4 shows the pavement photo of road (R1) having a rough surface with serious potholes. From this figure, it is observed that the crack occurred on the track of the vehicle wheels, and the potholes appeared in the middle of the road. This road experienced heavy traffic as it is one of the main roads for buses and trucks. Also, there is no side drains observed and uneven pavement surface which resulted in poor surface drainage. The recorded data indicated improper pavement design and construction, the design based on low traffic loads, using low-quality materials in construction, and following inappropriate design procedure. Therefore, insufficient pavement thickness, lack of construction materials and poor drainage may be the causes of these defects.

**Fig. 4:** damaged surface with large potholes on road R1

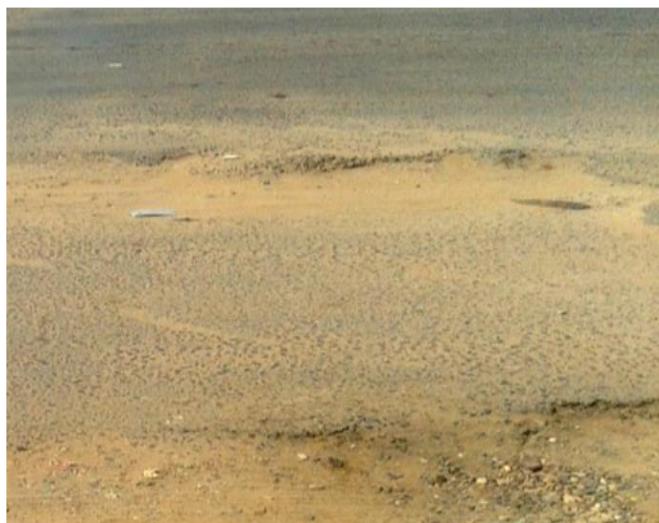
Fig. 5 shows the pavement of road (R4) that has severe potholes, cracks and failure in the side edges of the road. The distress area is too large and hinders traffic flow. It appears that the failure may be simply due to a weak subgrade of expansive clay soil, the problem associated with failure of the shoulders is likely linked to a problem in the subgrade soil. There are numerous failures associated with swelling soil in all sections of the road. The lack of adequate surface drainage is another critical factor that leads to problems with expansive soils.

**Fig. 5:** Dangerous potholes and edge failure of road (R4)
