Effect of Excavation Dewatering on Adjacent Structures

Magdi M. E. Zumrawi, Elhaytham Hassan

Abstract: The study aims to investigate the effect of dewatering technique on retained ground and adjacent existing structures in order to avoid any damages that may occur. The paper presents three cases of potential structure failure caused by ground settlement as a result of dewatering. Two current construction projects in Khartoum North were selected as a case study. The two projects are located near Blue Nile River where ground water table exists at shallow depths. Dewatering to reduce the groundwater level was carried out in the two sites to facilitate excavation works. The buildings and road pavements around the two sites suffered serious damages due to excessive differential settlements of the retained ground. The study results showed that there are numerous sources of risks associated with performing dewatering. Therefore, developing appropriate plan for dewatering before construction is essential to mitigate any adverse impacts and avoid risks.

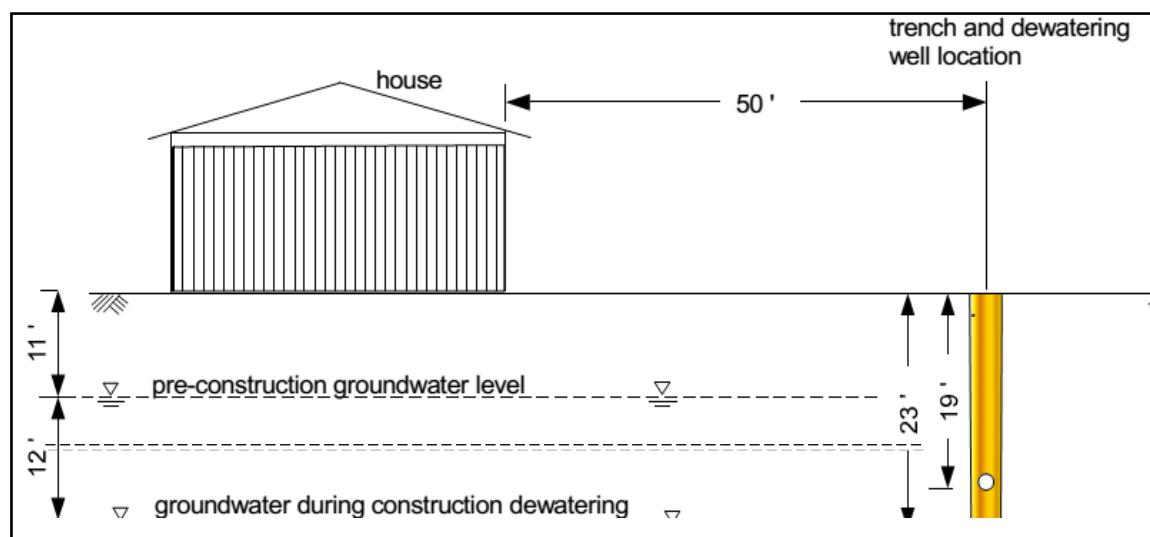
to provide clearance for pipe bedding gravel. The construction plans and specifications required that all work in the trench be conducted in the dry, including placement of the pipe bedding gravel and installation of the sewer pipe. Consequently, because of the presence of groundwater, dewatering was required during trenching and pipe installation. The structure influenced consisted of an approximately 24.4 m^2 ($2,200 \text{ ft}^2$) one-story wood house with a finished basement. This house was the closest structure to the trench and the contractor's primary dewatering well. The trench was excavated approximately parallel to the long axis of the house, about 15 m (50 ft.) from the back wall. The dewatering well was located about the same distance from the house as shown in Figure 2. Numerous irregularities in the interior of the subject home occurred, including drywall cracks in the ceiling, walls, and in many of the wall ceiling joints.

Currently available scientific methodologies and analytical methods indicate that the subject residence experienced damaging settlement as a result of groundwater lowering caused by nearby construction dewatering [13].

Fig. 2. The trench and dewatering well location at the project site, [13]
