## Visual Indicator-Based Thermal Inference (VITI) for Post-Fire Structural Assessment

<sup>1</sup>Department of Civil Engineering, University of Khartoum, Sudan

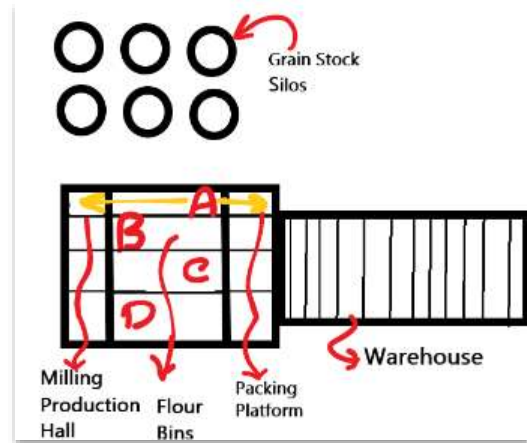
**Figure 2:** Factory X, Flour Mills Facility Layout

Factory X is a wheat flour-processing facility located in Sudan. The facility experienced a significant dust explosion combined with fire in 2022 [25], under

one of the flour bins in section B, leading to a complete halt in operations. The facility, an RC multi-story framed structure, comprises Wheat Silos, Production Hall, Flour Bins, Packing Platform, along with steel shed (Warehouse), as shown in **Figure 2**.

A, B, C & D are the four production lines

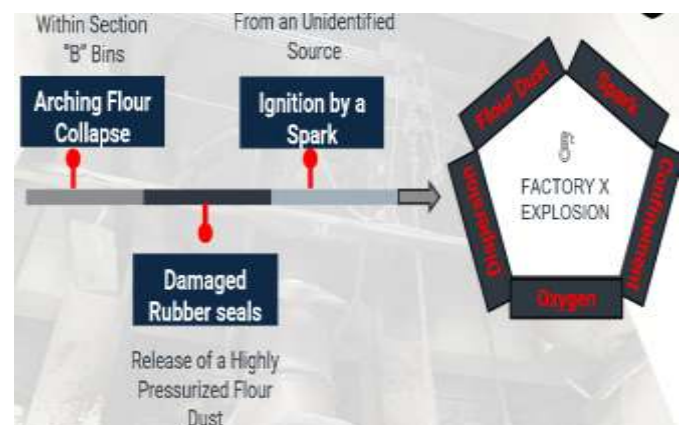
**Figure 3** Explosion incident in factory X and the developed Duat Pentagon

**Figure 3** summarizes explosion incident in factory X and how the Dust Pentagon developed, and mind map in **Figure 4** shows the effects of explosions on different aspects, while **Figure 5** shows the main explosion zone under wheat flour bins.

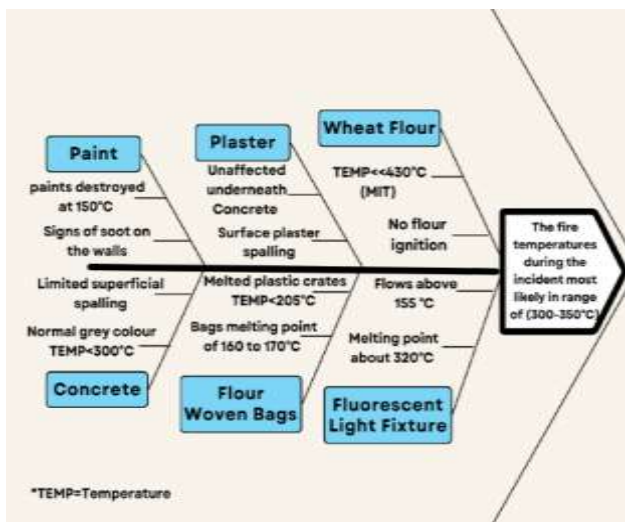
**Figure 6** Fish bone analysis of possible fire temperature during the Factory X fire incident

The fire temperature during the incident at Factory X was most likely in the range of 300-350  $^{\circ}\text{C}$ , high enough to damage plaster, paint, plastics and non-structural elements, but not sufficient to cause major loss of

concrete compressive strength. Based on established research, concrete exposed to temperatures below 350 °C typically retains 85-100% of its original compressive strength, and the elastic modulus reduction at this range is estimated at approximately 15-25%. Reinforcement steel properties would remain essentially unaffected at these temperatures [8], [11], [12] (**Figure 6**) (**Figure 7**).

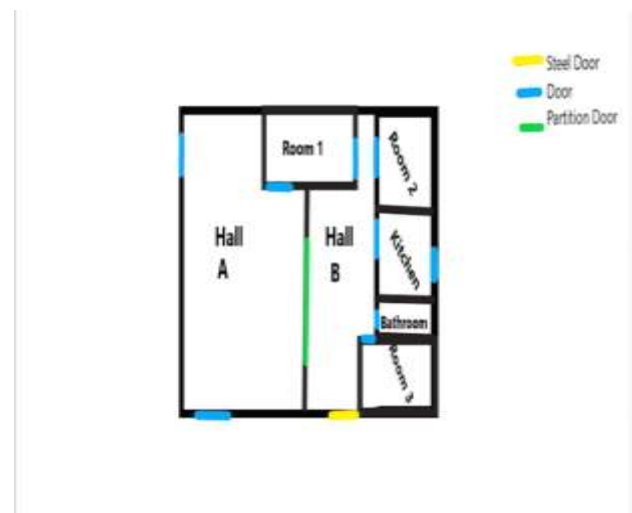
**Figure 8** Layout of the residential house ground floor

Jabra, Khartoum State, Sudan. The incident took place on M As a result of applying VITI the fire temperature during the incident was most likely did not exceed the range of 350-400 °C. Therefore, at temperatures below 400 °C, concrete is expected to retain approximately 80-100% of its compressive strength, with the elastic-modulus reduced by roughly 20-30%. Reinforcement steel yield strength remains largely unaffected below 400 °C [8], [11], [12]. No brick spalling or collapse was observed, indicating that load-bearing integrity of the structural walls likely remains intact, however superficial finishes and some RC elements require repair. It should be noted that the residential case study relies primarily on photographic and visual evidence without supplementary NDT verification. This limitation reflects real-world emergency assessment conditions where immediate NDT may not be available, and the findings should be treated as preliminary until further testing can be performed.ay 2024, during the ongoing conflicts in Sudan due to Unknown fire source and then spread to different parts of the house. **Figure 8** shows the layout of the residential house ground floor.
